4. TITLE (and Subtitle) Phase I Inspection Report Fresh Air Fund Dam No. 2 Hudson River Basin, Dutchess County, NY Inventory No. 726		5. TYPE OF REPORT & PERIOD COVERED Phase I Inspection Report National Dam Safety Program

PHASE I INSPECTION REPORT  
NATIONAL DAM SAFETY PROGRAM  
FRESH AIR FUND DAM NO. 2  
I.D. NO. N.Y. 726  
D.E.C. NO. 212D-3254  
HUDSON RIVER BASIN  
DUTCHESS COUNTY, NEW YORK

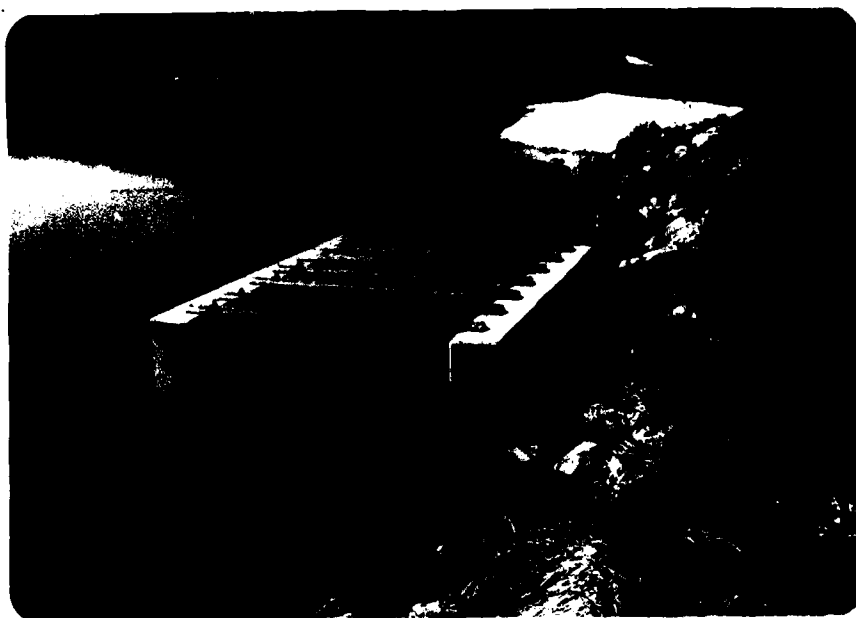
The intake structure appears to be in good condition (See Photograph No. 7). The trash rack angle irons show some signs of deterioration, and have broken loose in two places. Some boulders and twigs were seen at the bottom of the intake structure.

7. CONCRETE INTAKE STRUCTURE FOR SERVICE SPILLWAY.  
NOTE TRASH RACK.

6. Repair trash rack and clean riser intake structure.
7. Recoat exposed reservoir drain pipe with bituminous material.
8. Mark gate valve stem screw to designate the complete closure of reservoir drain gate.

e. Repair of trash racks and remove debris from intake structure.
